Evaluation of Destructive and Non-Destructive Testing of Existing Hotel Structures for Shopping Centre Conversion

Figure 1. Existing Condition of Ex. Hotel Mutiara 1 Building

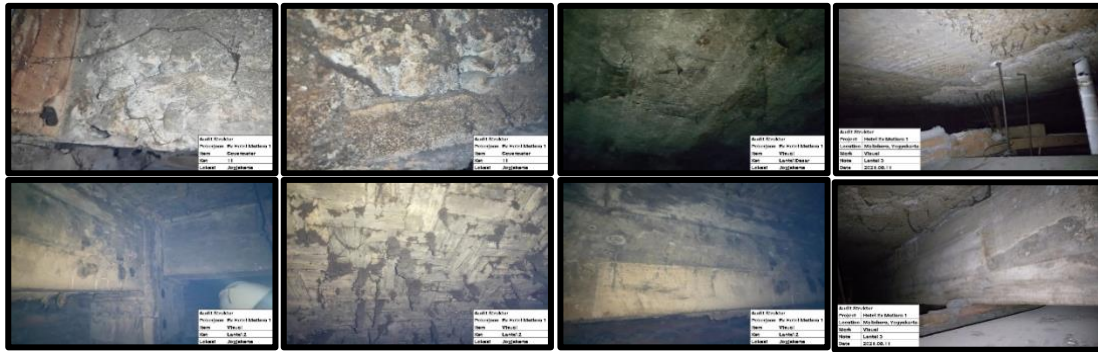
Based on the results of the visual survey, it can be seen that the condition of the column structure, beams and slabs is still quite good, but it can be seen that some concrete parts of the beam structure are segregated. The condition of the joint between the column structure and the beam is also still quite good. No structural damage was found in the columns, beams and plates.
