Evaluation The Optimization of Thermal Barrier Coating Stripping Methods on Inconel 939 Gas Turbine Vanes

I Kadek Dwi Wirawan Sadia*, Fahmi Mubarak

Institut Teknologi Sepuluh Nopember, Indonesia

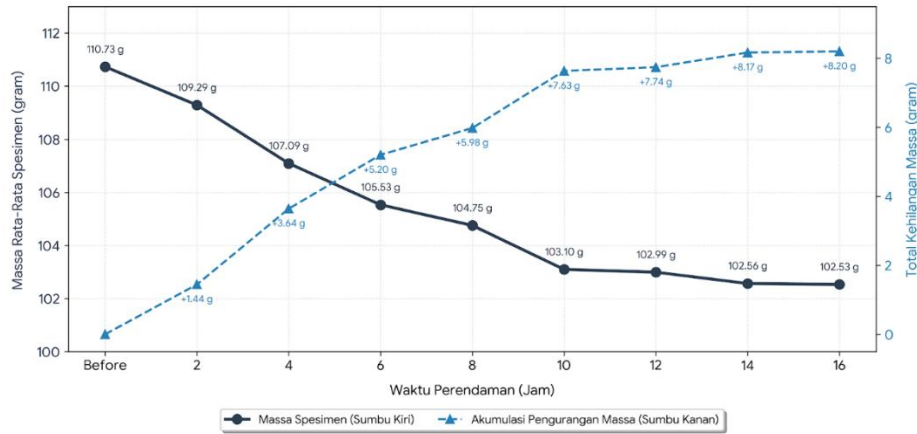
To determine the rate of depletion of the coating layer, the specimen is also measured by weight before and after the blasting process. Measurements are taken on scales with an accuracy of 0.001 grams. From the weight measurement results shown in figure 6, from the graph it is known that the weight of the specimen was reduced from 110.73 grams to 102.53 grams or about 8.20 grams of the coating layer that was peeled off when soaking using HCl 6 moles for 16 hours. From the data, it was found that the stripping rate of the HCl 6 mole method was 0.51 gr/hour. Figure 7 shows a graph of the weight of the specimen when immersed using 12 moles of HCl chemical liquid, the initial weight of the specimen was 105.099 to 99.058 grams during 10 hours of

Figure 6. Specimen Weight Reduction HCl Stripping Method 6 mole
Source: Authors' experimental data (2025)

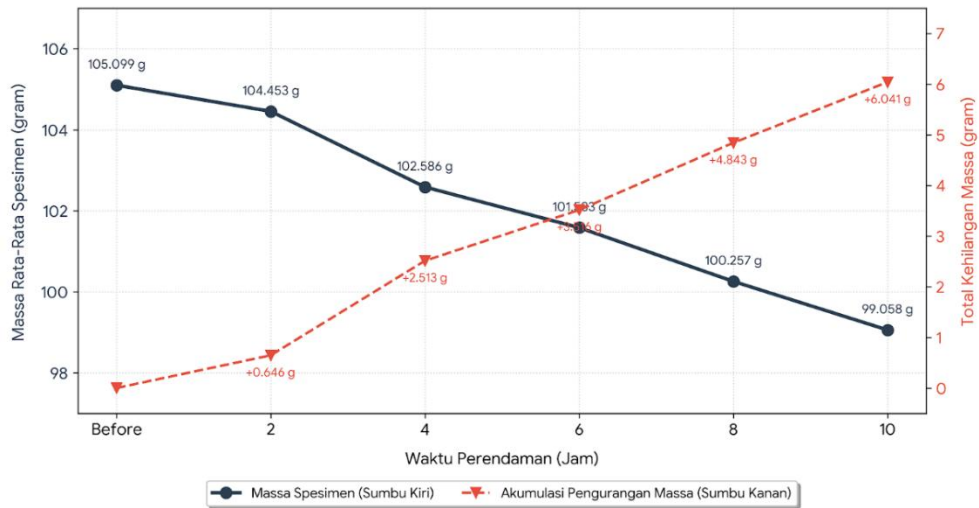
immersion or 6.041 grams of peeled coating and IDZ layers. So that the stripping rate from soaking using 16 mole HCl is 0.6041 gr/hour.

Figure 7. Specimen Weight Reduction 12 mole HCl Stripping Method
Source: Authors' experimental data (2025)

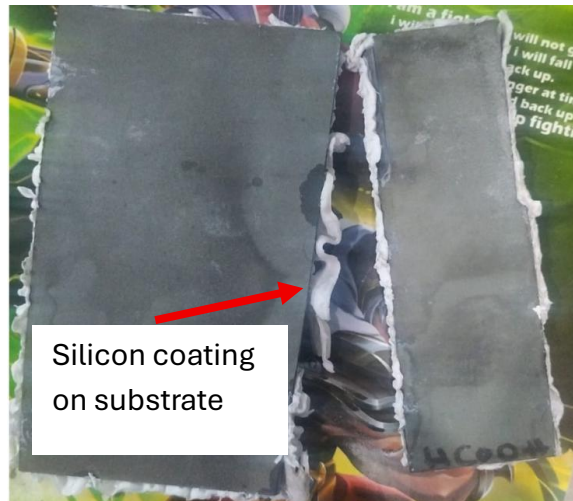
Table 2 shows the weight of INCONEL 939 specimen when the stripping method uses 6 moles of HCOOH liquid and 3 shows the weight of INCONEL 939 specimen when the stripping method uses 12 moles HCOOH fluid, both methods are performed for 48 hours. From the observations, it is known that the weight of the specimen becomes heavier and becomes not actual. This happens because HCOOH fluids tend to damage the silicon insulation layer coated on the base metal area that does not have a coating layer, so that the water layer tends to enter and fill the gap between the base metal and the silicon layer. Visualization of the silicon layer on the base coating layer is shown in Figure 8.

Figure 8. Silicon layer on substrate

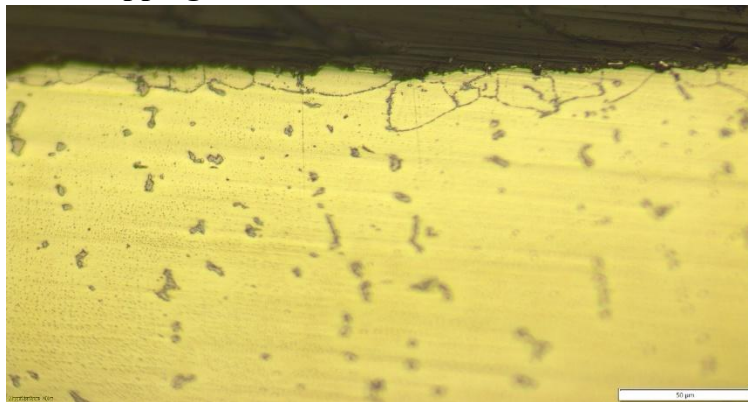
Figure 10. Cross Section Cross-Section in INCONEL 939 after soaking with HCl 12 Mol for 10 hours

The results of the micrograph analysis showed that the IDZ layer had completely detached. This is very good for the next coating process, because the brittle IDZ layer has gone through the stripping process perfectly.

The results of micrography testing showed that the carbides in the area around the surface did not increase in size and did not connect with each other. This separate carbide makes the structure of the grain boundary more stable.

In the grain boundary area shows carbide buildup, this carbide buildup can cause crack initiation when the substrate/vane is operating. Based on the visual appearance, there is no corrosion in the grain boundary area. This indicates that the HCl liquid has not yet invaded the grain boundary of the substrate.

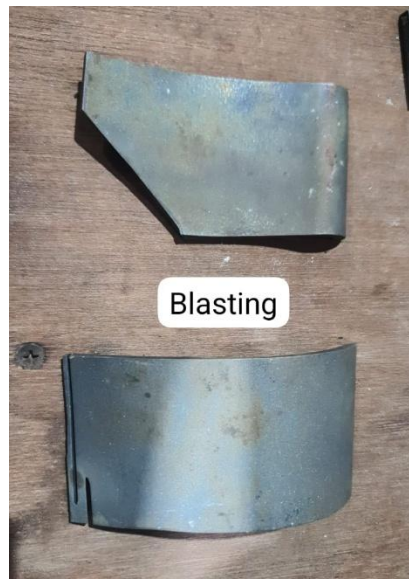
Figure 14. INCONEL 939 specimen after the heat-in process
Source: Authors' experimental data (2025)

Figure 14 shows that the color of the specimen after the heat-in process still has a gray layer, where the layer is the remaining coating layer, while the blue layer is the base metal layer. It can be seen that the remaining coating layer spreads unevenly on the base metal layer. There are layers that have been completely eroded in certain parts and there are some layers of coating that still remain.

The disadvantage of using grit blasting is also found in the homogeneity of the bond coating layer removal process. When doing the heat-in process, it can be seen that there are still many layers of coating left behind and have not been completely peeled off.
