## Coupler Modification for Periodic Preventive Maintenance on Sakai SV526D and SV700TF Compactor Units to Improve The Efficiency and Reliability of Hydraulic System Inspection

PT Antareja Mahada Makmur, Indonesia

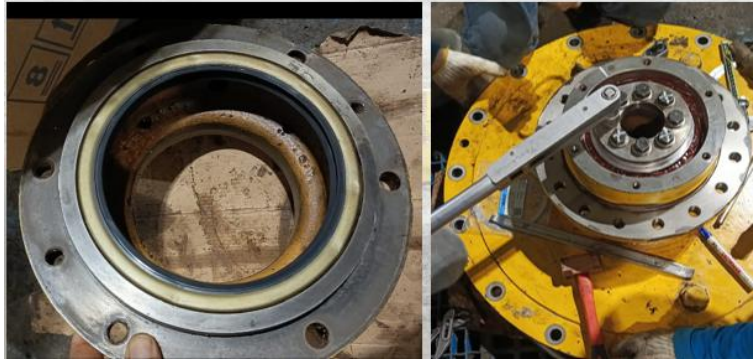
**Figure 2.** Propulsion/drive motor component removed from the unit due to damage suspected to be related to the hydraulic PPM not running optimally

| Aspect | Identified Problematic Condition |
|---|---|
| Actual Field Impact | Damage was found in the vibration motor seal, parking brake seal, and rear propulsion motor due to the hydraulic PPM not running optimally |

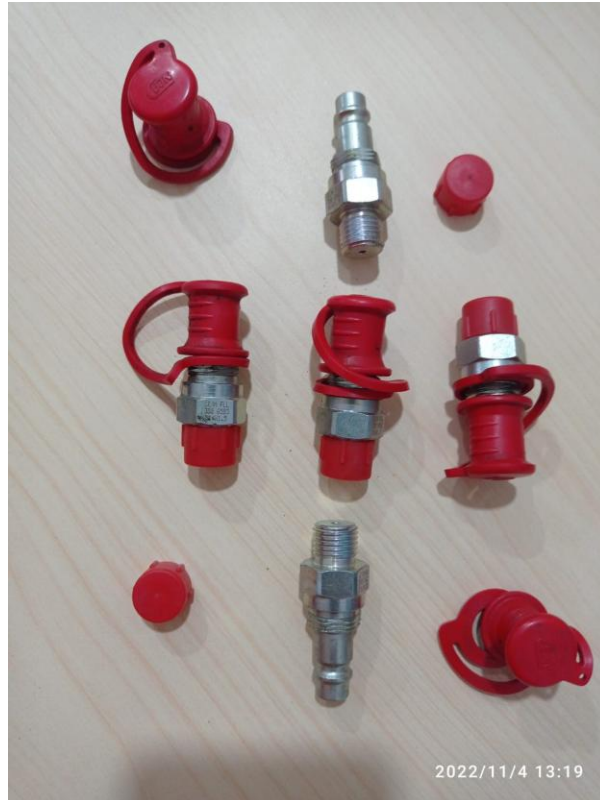
**Figure 3.** The original Sakai manufacturer PPM coupler (left) and its incompatible connection with the Genuine Komatsu pressure gauge tools, before modification.

The field identification results show that the main root cause was a mismatch between the original Sakai manufacturer coupler on the PPM port of the SV526D and SV700TF units and the Genuine Komatsu pressure gauge tools already owned internally by the Plant Department. As a result, the only official option for checking hydraulic system pressure was to procure a special pressure gauge tool set from the Sakai dealer (SWI) priced at IDR8,696,215, which, at the time this study was conducted, remained on backorder with no certainty as to its arrival time. This condition caused the PPM process on the hydraulic system to be unable to be carried out optimally for a considerable period, as summarized in Table 2.

The solution was implemented by procuring Genuine Komatsu PPM couplers with part number 799-101-5230, with a requirement of five coupler units per machine, to be installed in place of the original coupler on the PPM port of the Sakai SV526D and SV700TF units. The Genuine Komatsu coupler was selected based on the compatibility of its dimensions and locking mechanism with the Komatsu pressure gauge tools already available internally, so that the adaptation process could be carried out without requiring investment in a new tool. This modification also aimed to reduce the lost-time duration arising from the coupler removal-installation process, which had previously been less efficient with the original port configuration.
