Analysis of Cost Estimation and Road Surface Assessment of Kemlagi - Berat Kulon Road Section of Mojokerto District Using SDI Method

Fikri Jadmiko^{1*}, Wateno Oetomo², Risma Marleno³

Universitas 17 Agustus 1945 Surabaya, Indonesia

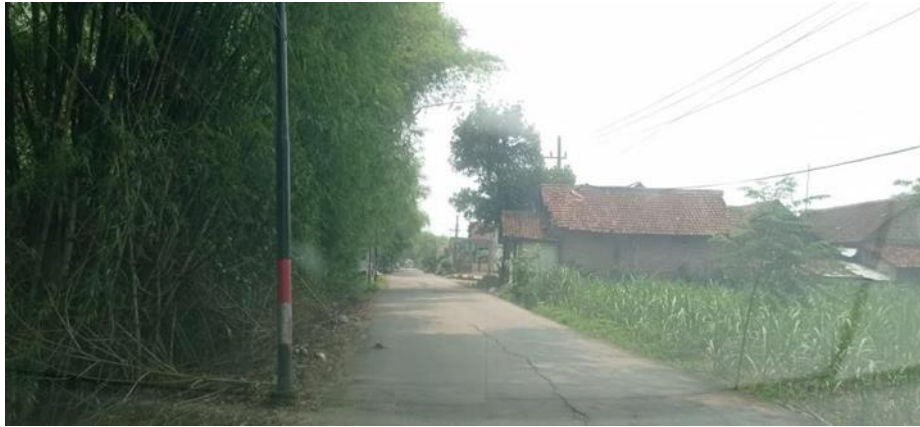
Figure 1. Longitudinal Crack

1. Longitudinal crack

Cracks generally occur in the center of the concrete pavement, parallel to the road axis or traffic direction.

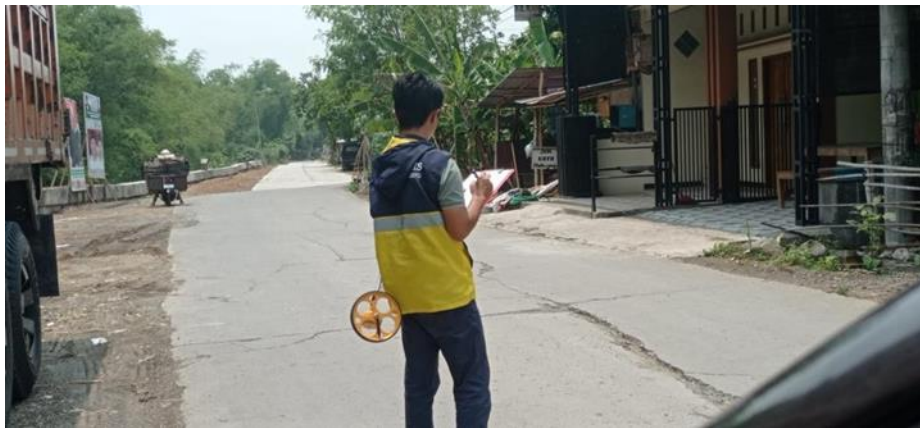
Figure 2. Transverse Crack

2. Transverse Crack

Cracks that occur in the direction of the width of the concrete pavement and are almost perpendicular to the axis of the road.

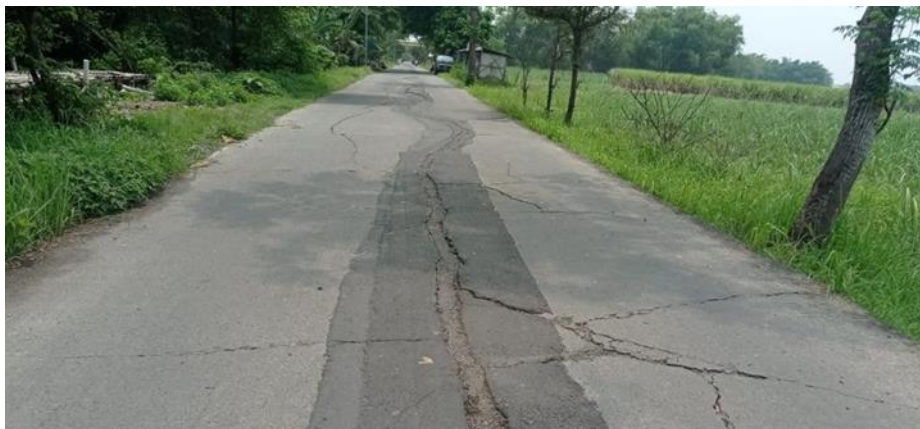
Figure 3. Joint Spalling

3. Joint spalling

The breakage of the edge of the concrete slab around the joint usually does not form a vertical plane but forms an angle to the flat plane.

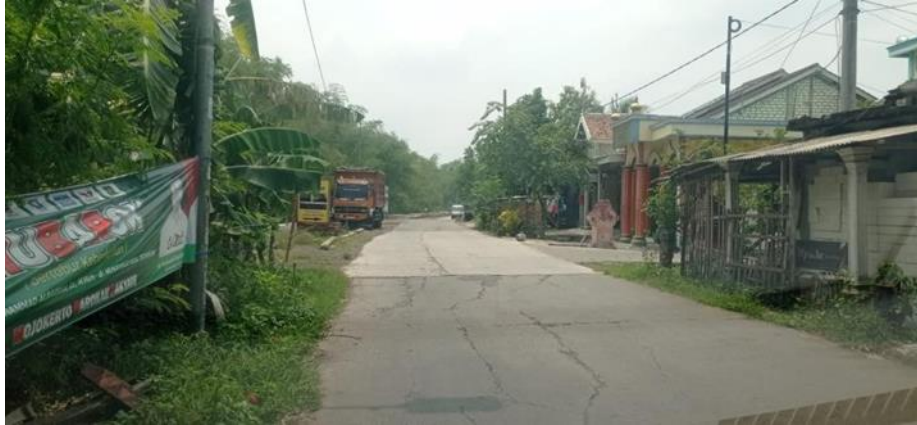
Figure 4. Corner Breaks

4. Corner Breaks

A rupture occurs at the corner of a concrete slab that intersects a joint at a distance less than or equal to $\frac{1}{2}$ of the length of the slab on both sides of its length and width, measured from the corner of the slab.

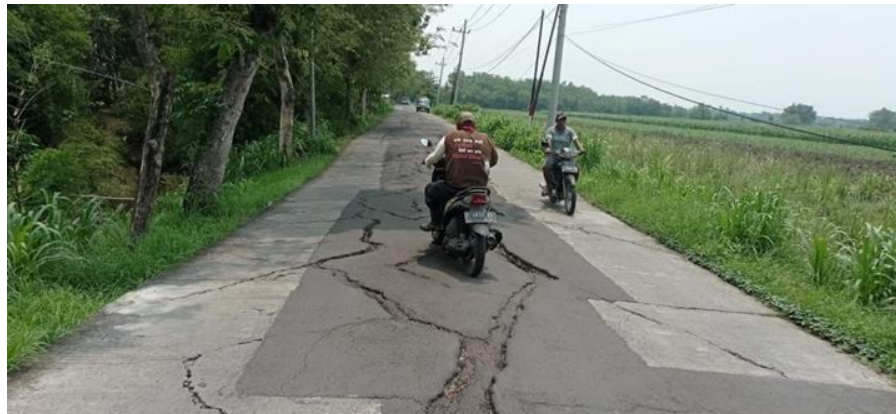
Figure 5. Pumping

5. Pumping

Movement or uplift of material under a concrete slab due to water pressure through joints or cracks.
